Re-Use Options Comparison – Monmouth Middle School

For: Town of Monmouth

Client:	Town of Monmouth, Maine	Date:	9/16/20
Client Contact:	Ms. Linda Cohen	Project #:	200316-01
		Proposal #:	2013-1009
Project Name:	Building Evaluation – Monmouth Middle School	P.O. #:	31604

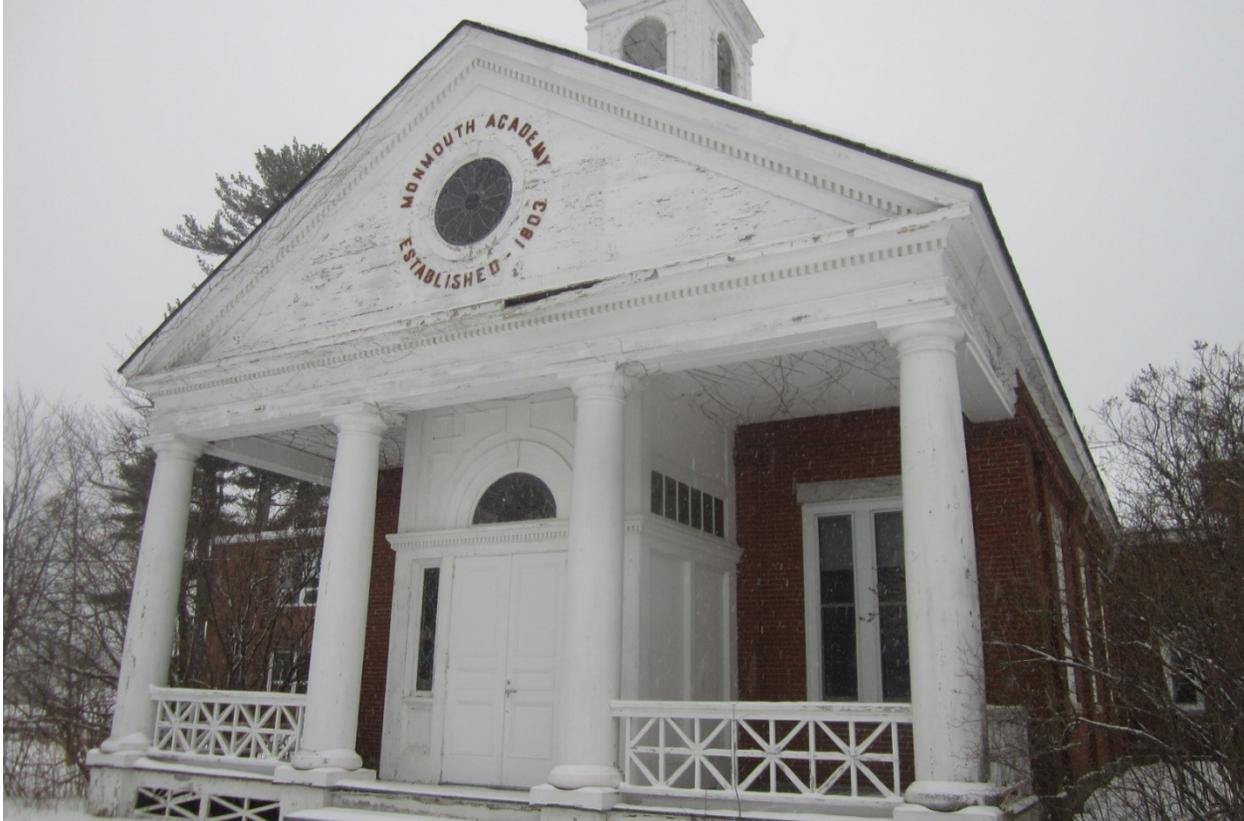
Option 1: Remove/demolish all buildings except original Academy building. Create public green space adjacent to fairgrounds

The first option to be considered is the retention and renovation of the original Monmouth Academy building, the portion of the building constructed in 1856. This would include the demolition of the A and B Wings, the 1952 Building (including the gym) and the Connector. As noted in the option description, this also includes the creation of a “green space” to the south of the Academy building between it and the fairgrounds. This effort is estimated to include the clearing of the majority of the trees currently in that area, filling in the ground left by the A Wing, grading and seeding the area with grass, and then replanting a variety of shrubs and trees to make the area more visually appealing. Budgetary estimates were used for this green space creation, but there a wide number of variables to consider when creating an area such as this and more accurate pricing will be attainable when design decisions are made.

Unique considerations for retaining this portion of the building include the need for an accessible elevator to access the second floor, as well as a staircase as the only way to access the second floor currently are the stairs located in the B-Wing. Also, when the B-Wing is demo'd, new exterior walls will need to be constructed on the north and south sides of the building where the B-Wing had been connected to the building.

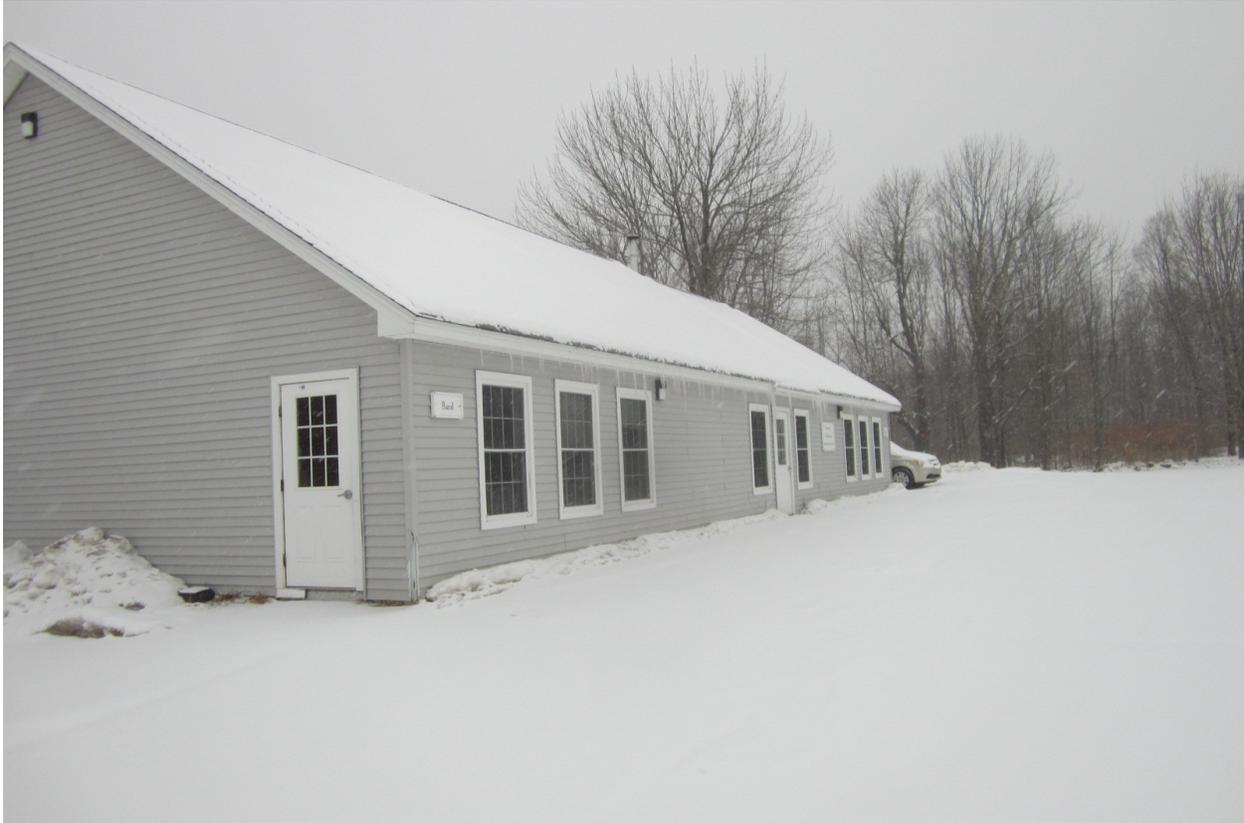
Option 3: Remove / Demolish All Buildings, Including the Old Academy. Use Former Supt. Building As Community or Recreation Space:

This option includes the demolition of the middle school building as noted in the previous option. The same notes apply here.

Re-utilizing the former superintendent building as a community center or recreation space should have minimal costs associated with it. It should be noted that this building was not included in the scope of the original assessment and was not accessible at the time that the middle school was assessed. However, it is a single story structure, which eliminates any costs associated with accessibility requirements needed for multi-story buildings such as elevators. Additionally, as this is a newer building, it is both more likely to be code-compliant with most modern code requirements and there are likely far fewer building systems that have reached or exceeded their expected lifespan. An assessment of this building would be required to quantify which buildings may be in need of renewal and the costs associated with doing so.

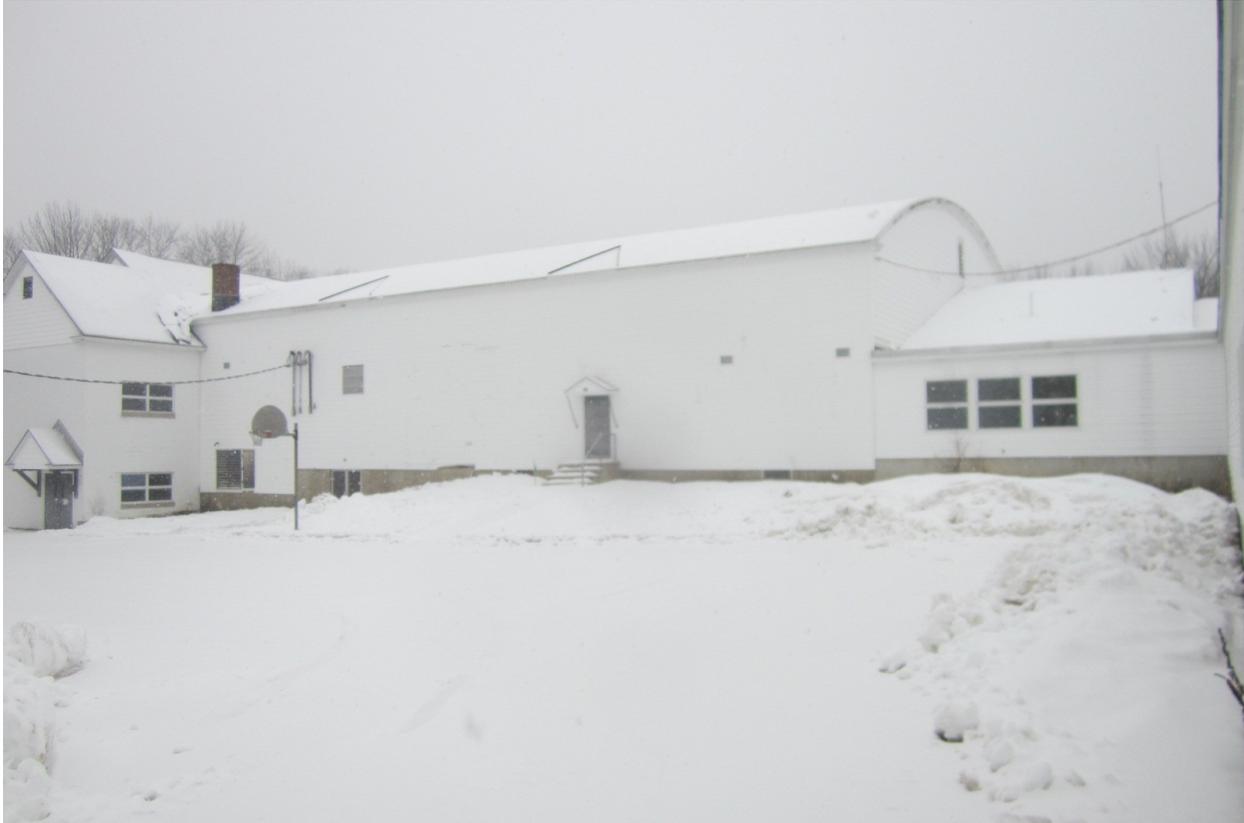
Option 4: Demolish Back Wing and A/B Wings. Retain Gym for Rec / Community Center and Old Academy:

This option allows for the re-use of two portions of the existing building – the original Academy building and the Gym. The re-use of these portions of the building allow for a variety of potential uses and represent the most utilitarian portions of the building.

This option will require the construction of new exterior walls where attached additions are to be demo'd. Specifically this includes the Connector building and the A-Wing. The construction of these walls is budgeted for painted CMU to match the other adjacent exterior walls.
